What we've measured at Pit

Layer4 of Stack4

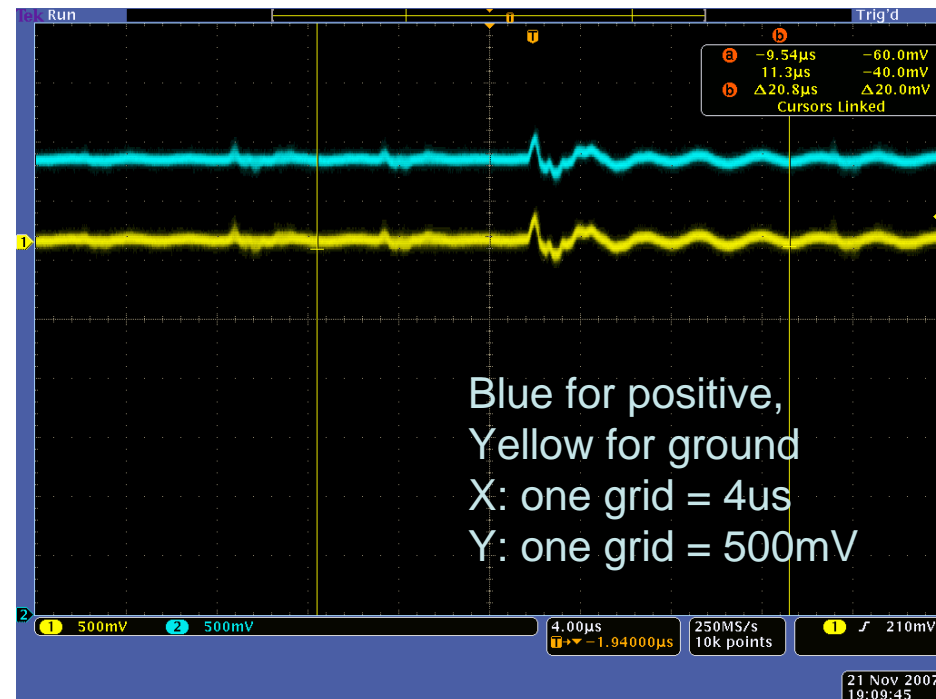
- Don't know whether it is due to the PL512 or something else
- We checked voltage signal at the backside of power supply with oscilloscope at A3.3 for Layer 4,5 without robpower on:(see below)

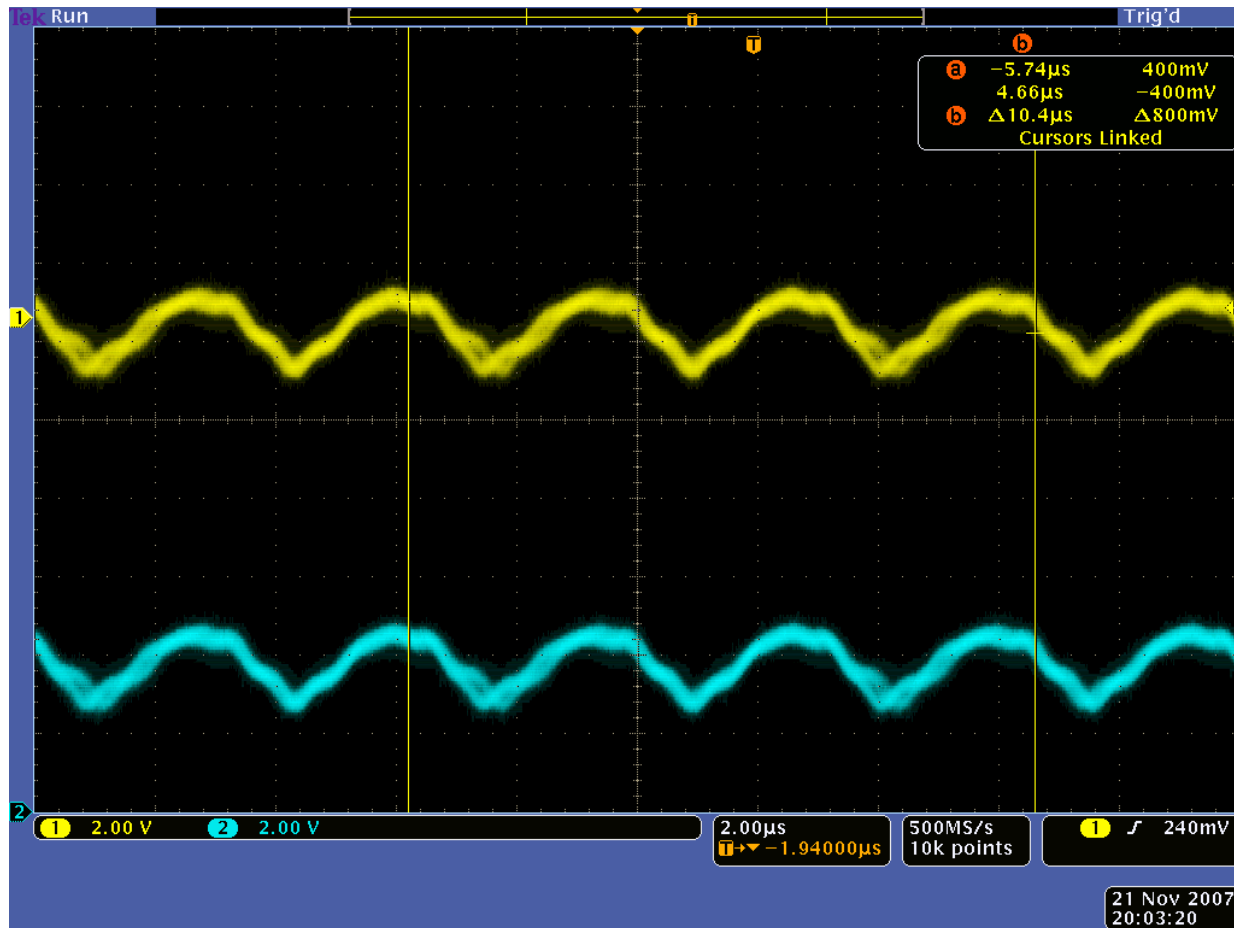
- We checked voltage signal at the backside of power supply with oscilloscope at A3.3 for Layer 4,5 with robpower on:(see below)
- PS + and grounding is fluctuating $\pm 1V$ from rack ground with same phase (can it be a problem to PASA?)

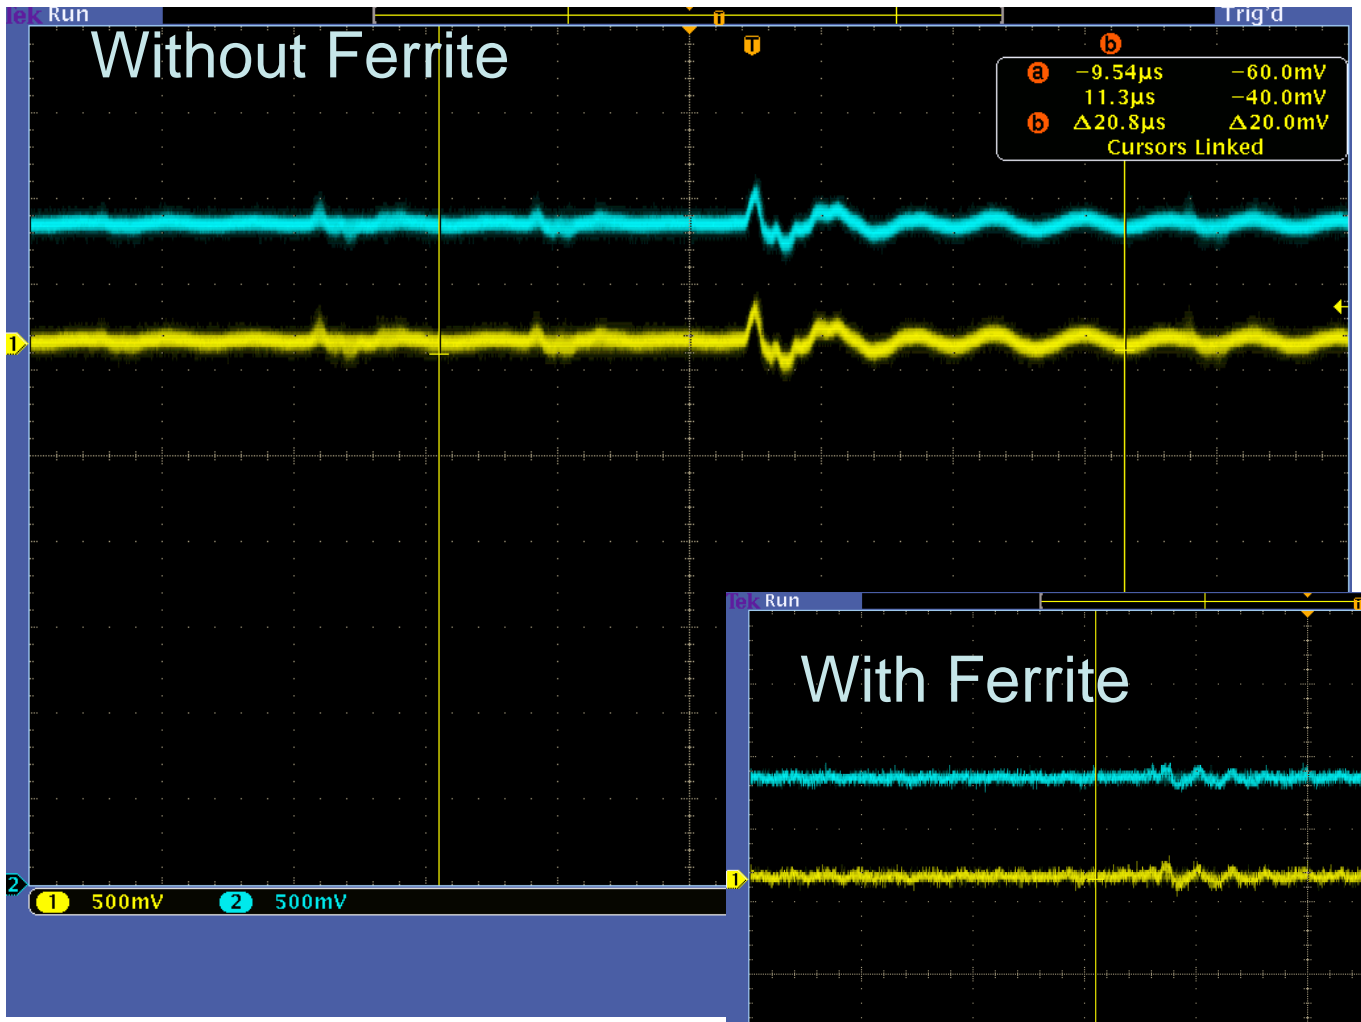
- Then, measured the noise again

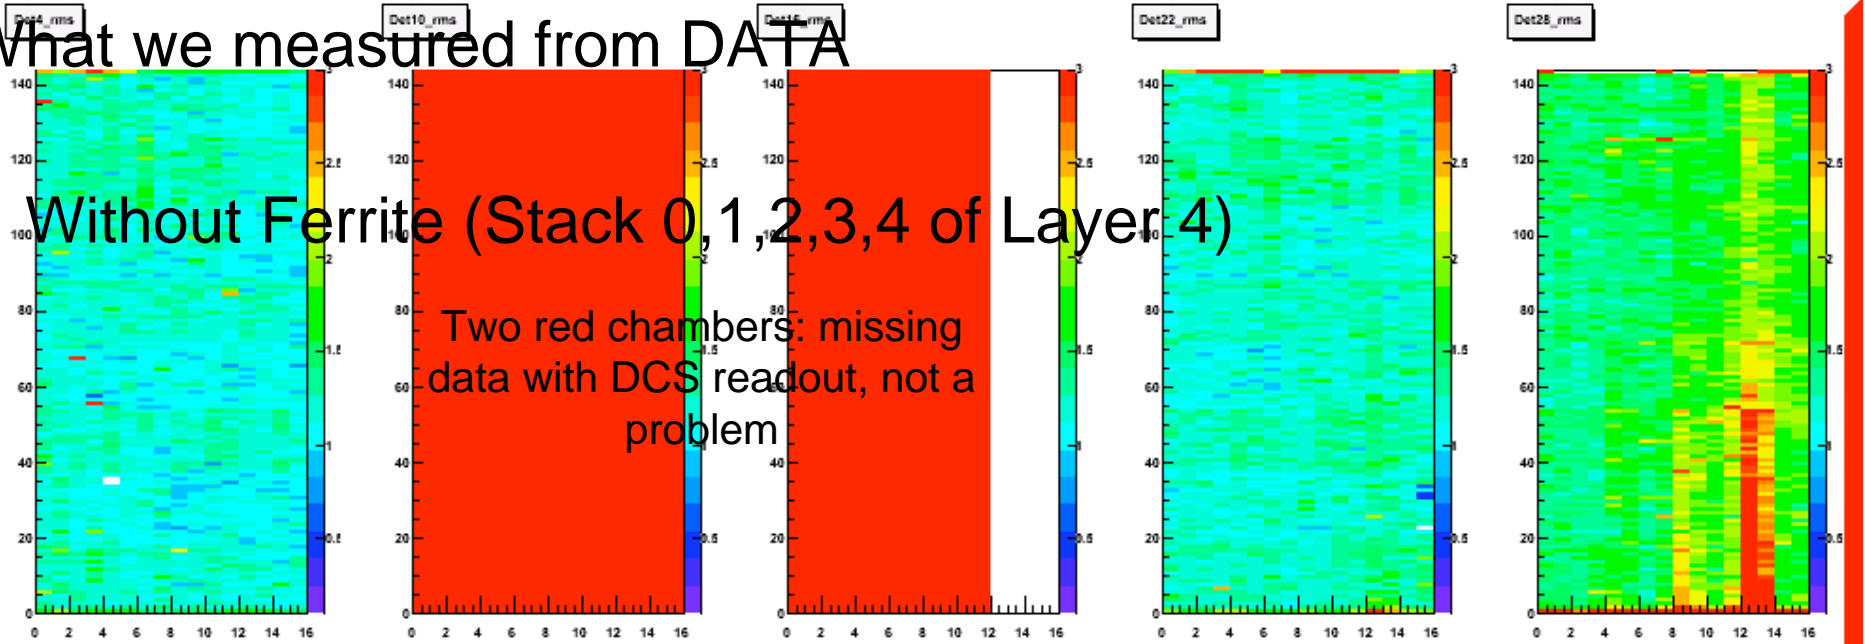
Without Ferrite (Stack 0,1,2,3,4 of Layer 4)

Two red chambers: missing data with DCS readout, not a problem

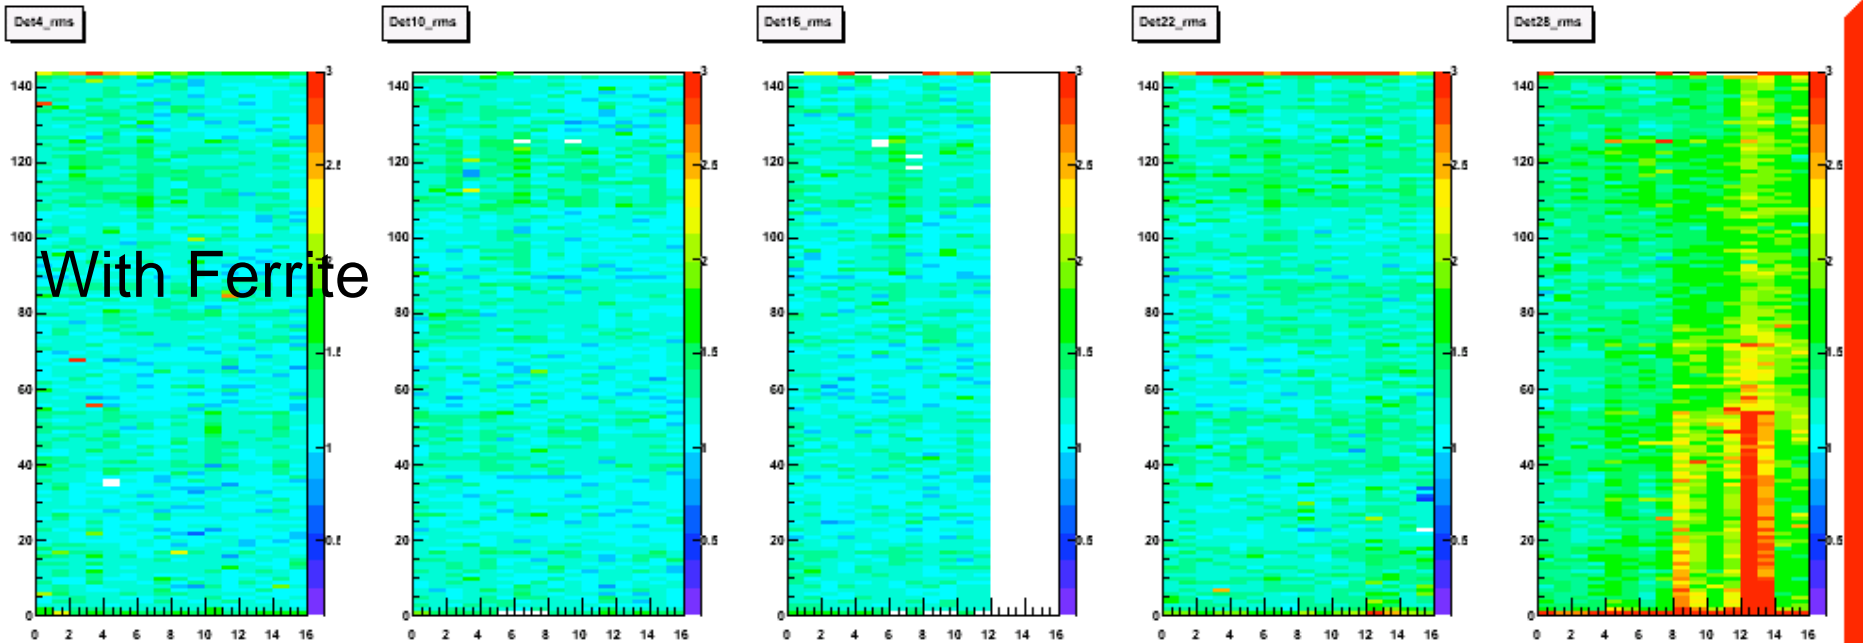
With Ferrite

- We don't see noise reduction with the ferrite installation at pit
- Then, the noise we see at the last stack
 - might not from the LV PL512
 - if it is due to LVPL512, still the ferrite is not suitable for the noise reduction
 - we are also checking SM grounding to space frame (we will change some ground connection and see if gives difference)
 - if it doesn't give difference, we check with PL508 to conclude if it is really power supply problem
- Does the ferrite help for TPC?

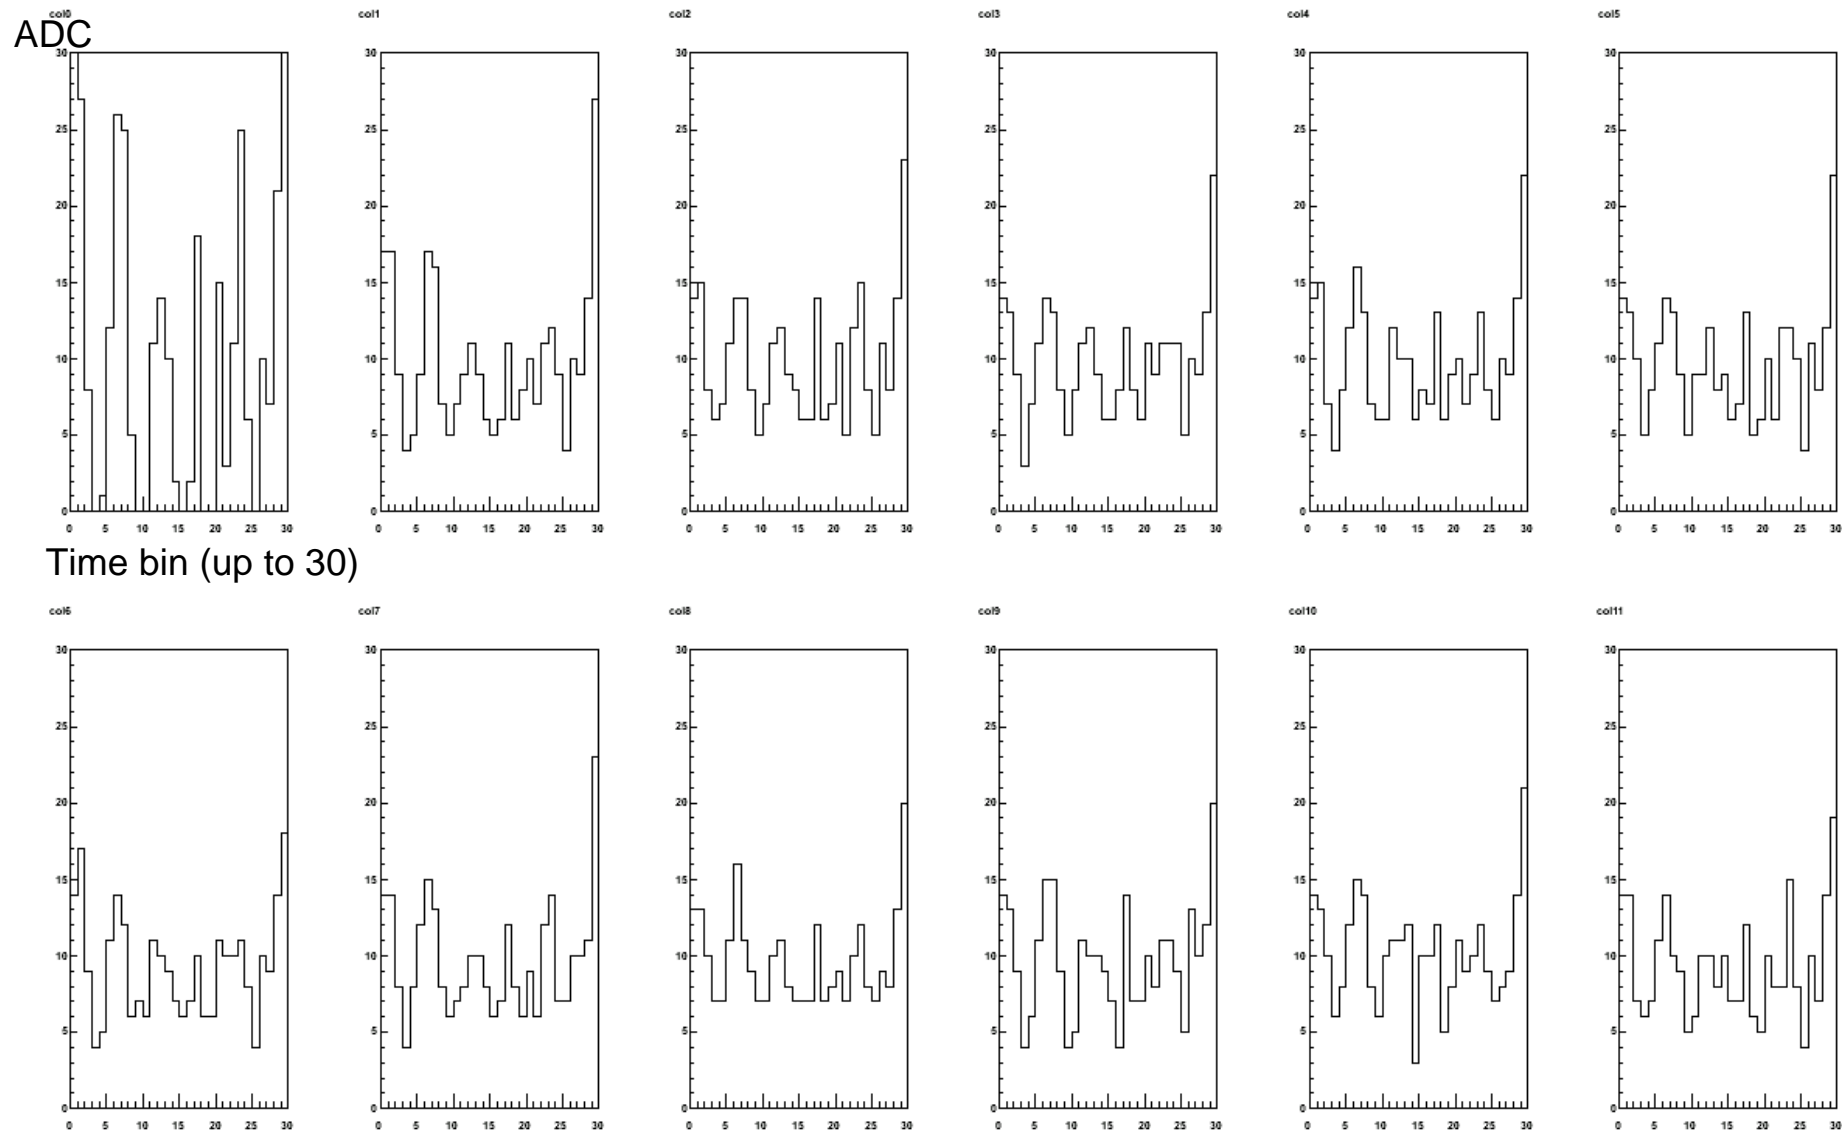
With Ferrite, we still see this type of noise(600ns) from data at the most noisy pixels
