What we've measured at Pit

Layer4 of Stack4

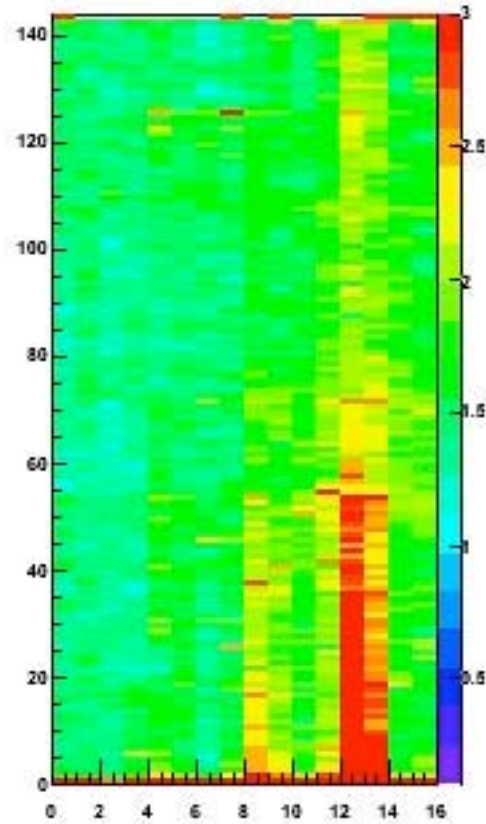
- Don't know whether it is due to the PL512 or something else
- We checked voltage signal at the backside of power supply with oscilloscope at A3.3 for Layer 4,5 without robpower on:(see below)

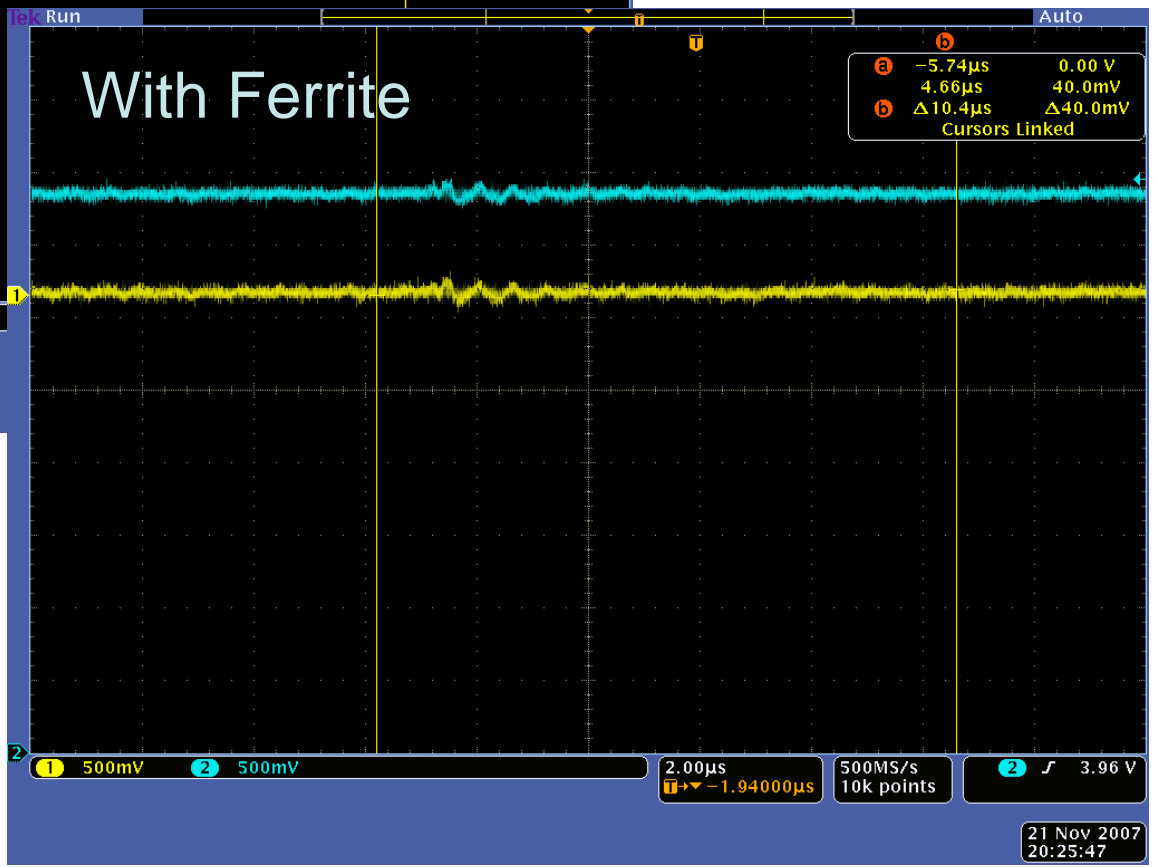
- What we measured from oscilloscope

- We don't see noise reduction with the ferrite installation at pit
- Then, the noise we see at the last stack
 - might not from the LV PL512
 - if it is due to LVPL512, still the ferrite is not suitable for the noise reduction
 - we are also checking SM grounding to space frame (we will change some ground connection and see if gives difference)
 - if it doesn't give difference, we check with PL508 to conclude if it is really power supply problem
- Does the ferrite help for TPC?
